**Field Report for 2016 SPME Porewater Sampling and Surface Sediment Sampling
River Mile 10.9 Removal Action
Lower Passaic River Study Area**

December 8, 2016

This field report describes the solid-phase microextraction (SPME) porewater sampling and surface sediment sampling performed of the cap at the River Mile 10.9 (RM 10.9) Removal Area. The SPME samplers were deployed over three days in June 2016 and were recovered over three days in August 2016. During SPME sampler recovery, samples of surface sediments that had accumulated since cap construction were also collected. A representative of Region 2 (from CDM Smith) was present during all field activities. This field report also describes the visual cap inspection performed over two days in July 2016. This work was performed as described in the Lower Passaic River Study Area River Mile 10.9 Post-Construction Monitoring Quality Assurance Project Plan, Revision 2 (QAPP) submitted to US EPA Region 2 (Region 2) on April 12, 2016 and the draft River Mile 10.9 Removal Action Long-Term Monitoring and Maintenance Plan, Revision 2, submitted to Region 2 on April 12, 2016 (LTMMP). A subsequent revision to the QAPP (Revision 3) was submitt

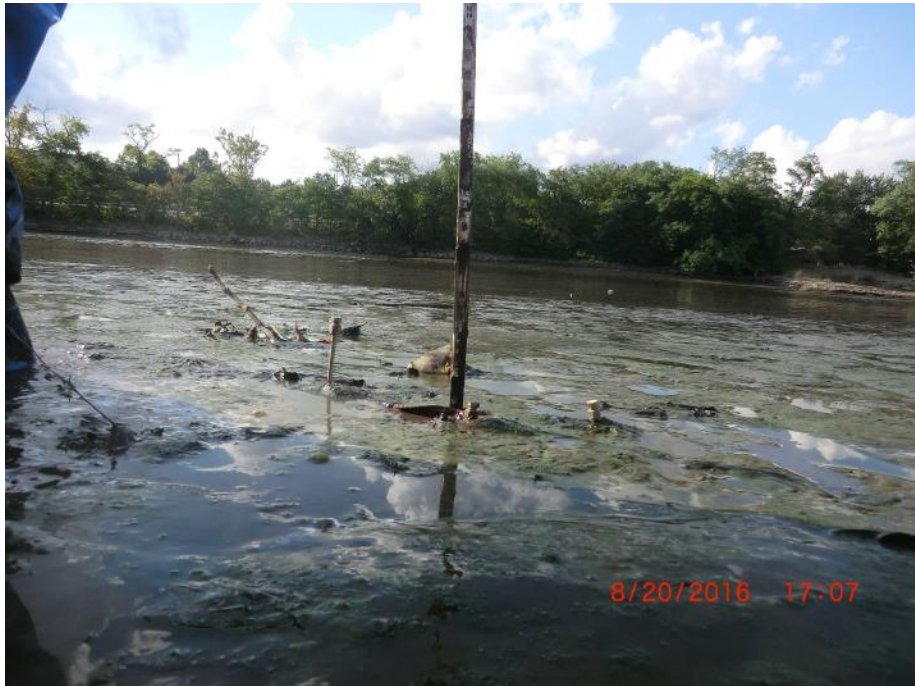
PHOTOGRAPHIC LOG		
Client Name: Cooperating Parties Group		Site Location: Lower Passaic River (River Mile 10.9)
Project No. 60270961		
Photo No. 5	Date: 08202016

Direction Photo Taken: Northwest		
Description: Station 16A-0605

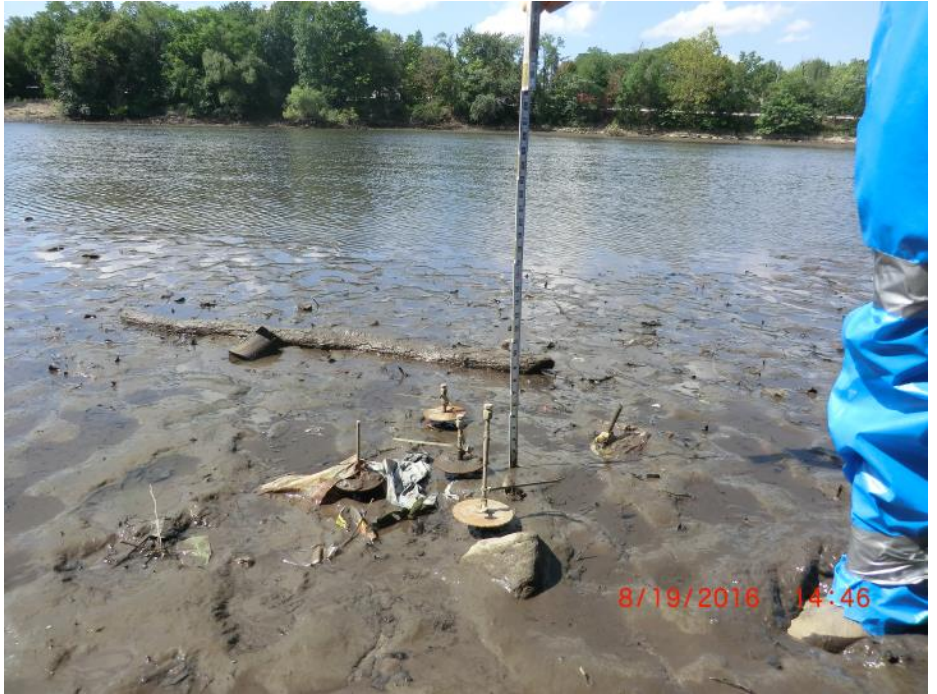
PHOTOGRAPHIC LOG		
Client Name: Cooperating Parties Group		Site Location: Lower Passaic River (River Mile 10.9)
Project No. 60270961		
Photo No. 7	Date: 08192016

Direction Photo Taken: North		
Description: Station 16A-0607

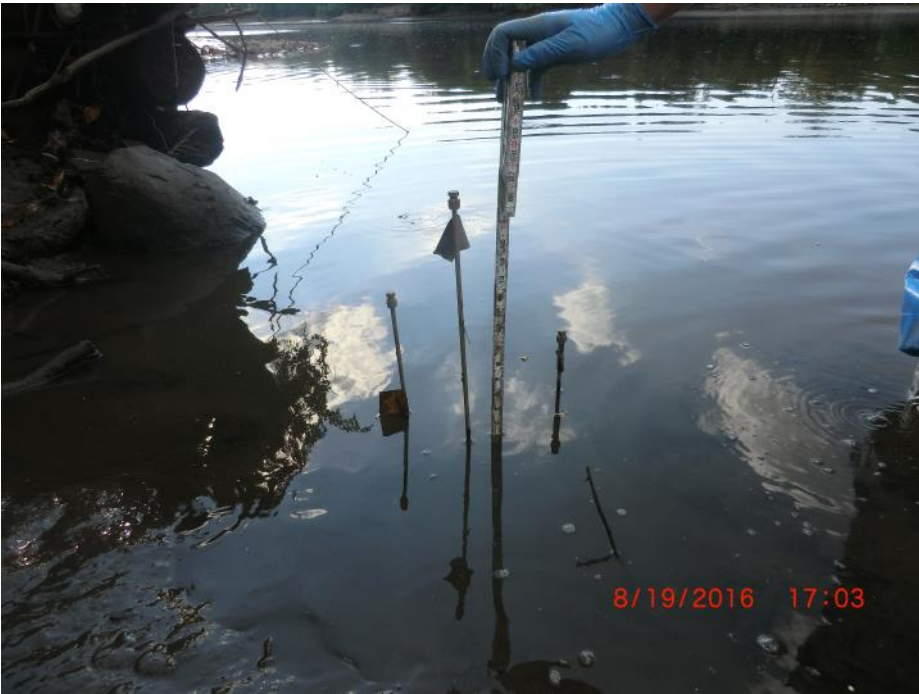
PHOTOGRAPHIC LOG		
Client Name: Cooperating Parties Group		Site Location: Lower Passaic River (River Mile 10.9)
Project No. 60270961		
Photo No. 9	Date: 08192016

Direction Photo Taken: North		
Description: Station16A-0609 (Samplers installed in water in June. Picture taken 10 min before low tide.)

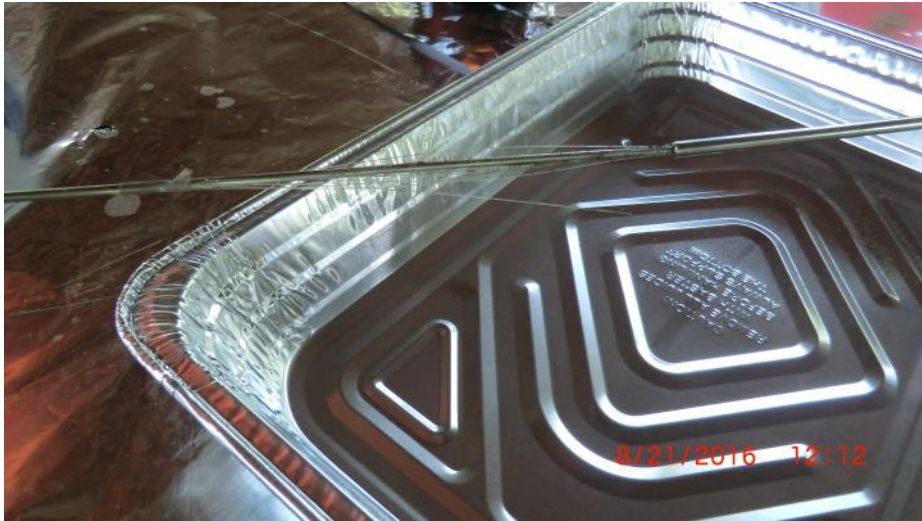
PHOTOGRAPHIC LOG		
Client Name: Cooperating Parties Group		Site Location: Lower Passaic River (River Mile 10.9)
Project No. 60270961		
Photo No. 13	Date: 08212016

Direction Photo Taken: NA		
Description: Removing SPME fibers from Henry sampler

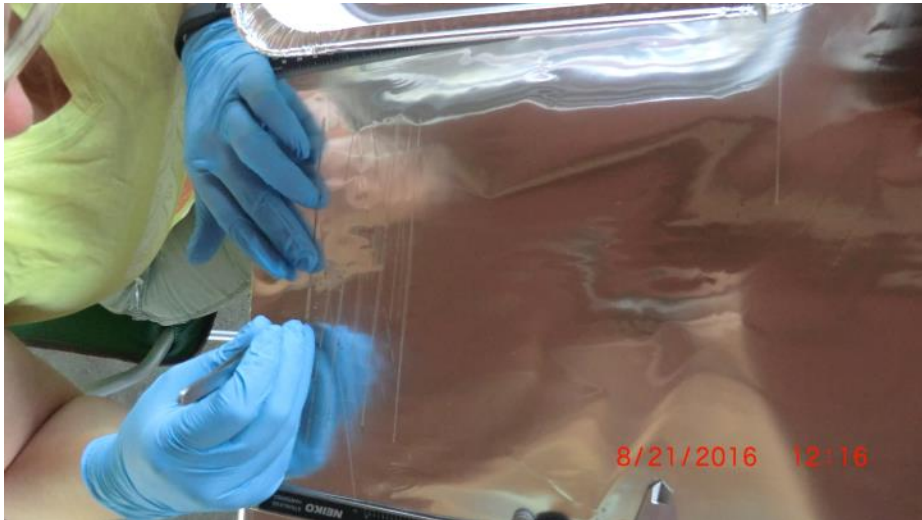
Photo No. 14	Date: 08212016

Direction Photo Taken: NA		
Description: Processing SPME fibers extracted from Henry Sampler.

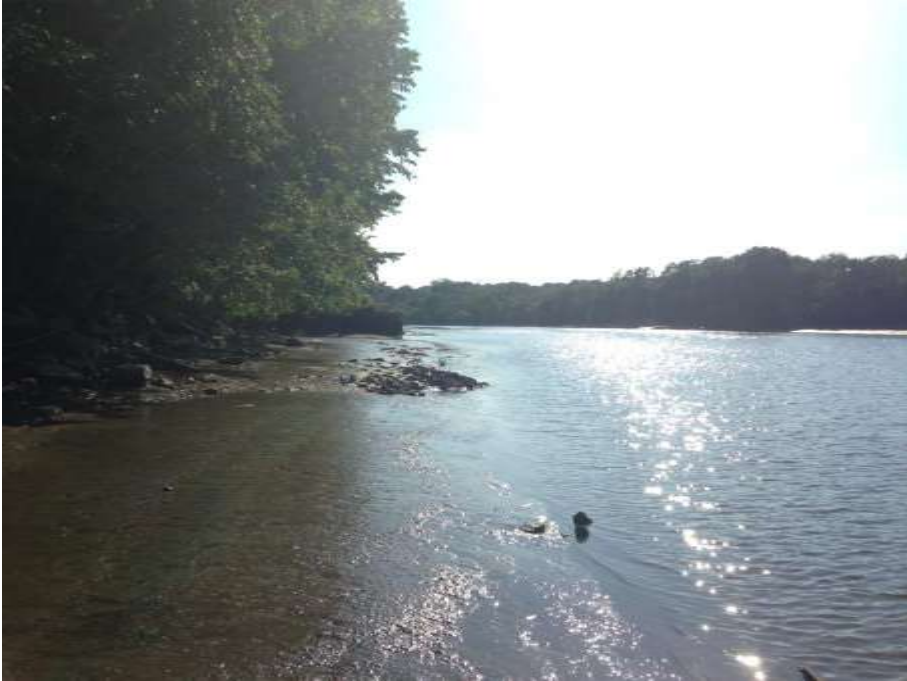
Photo No. 4	Date: 07062016

Direction Photo Taken: West		
Description: Annual Cap Inspection Looking downriver toward station 16A-0609 from station 16A-0610.

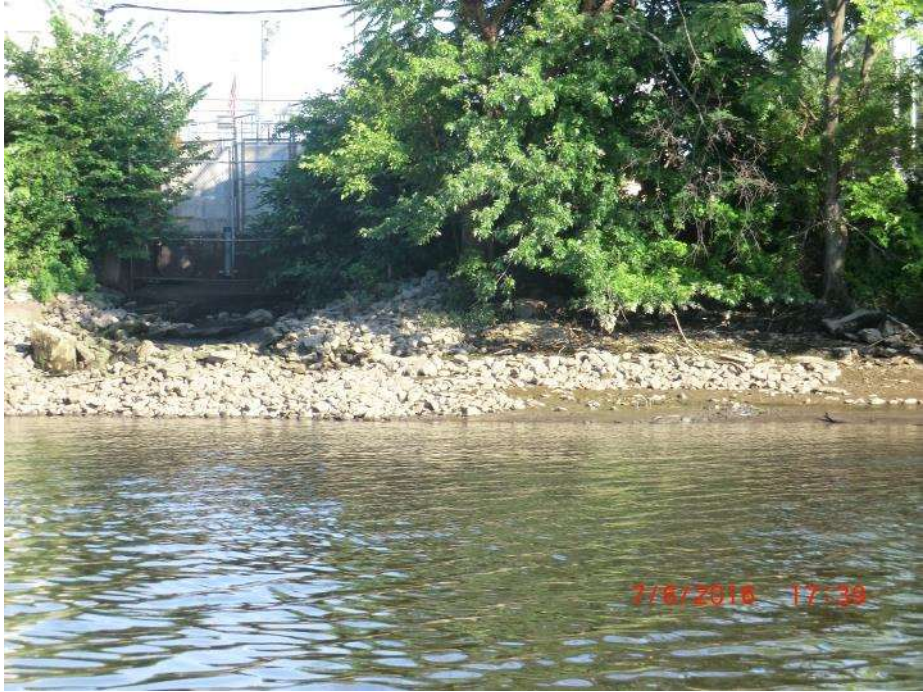
PHOTOGRAPHIC LOG		
Client Name: DMI		Site Location: Lower Passaic River (River Mile 10.9)
Project No. 60270961		
Photo No. 7	Date: 07062016

Direction Photo Taken: South		
Description: Annual Cap Inspection Shoreline at station 16A-0610 during low tide event.

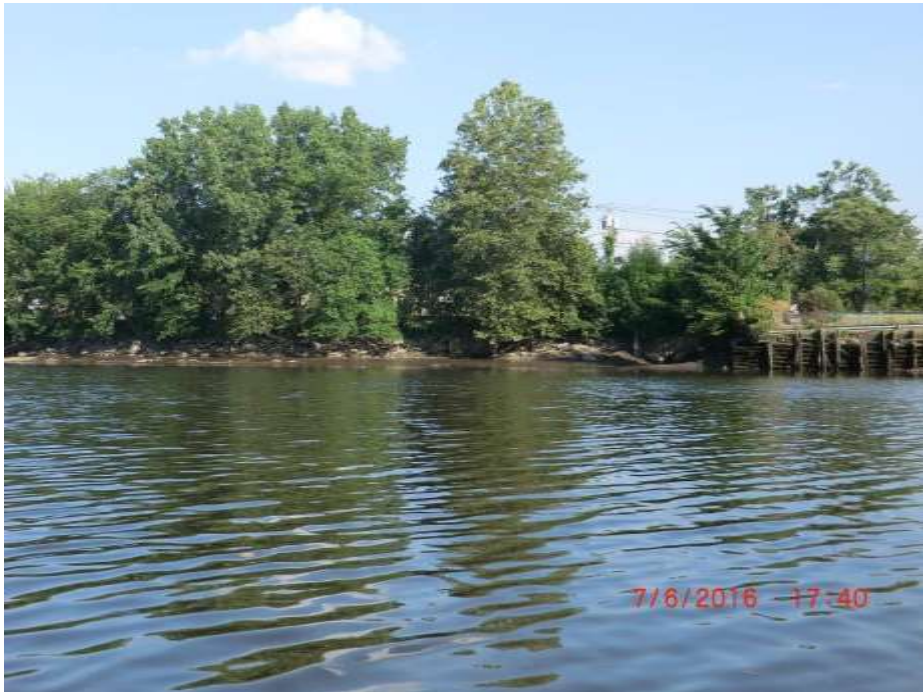
Photo No. 8	Date: 07062016

Direction Photo Taken: South		
Description: Annual Cap Inspection Shoreline at station 16A-0609 during low tide event.

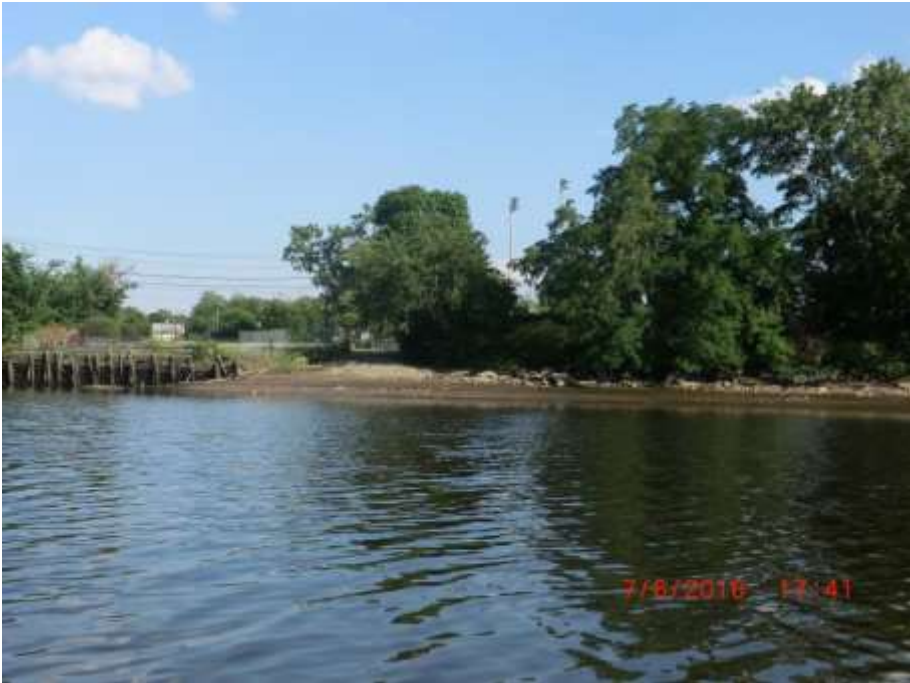
PHOTOGRAPHIC LOG		
Client Name: DMI		Site Location: Lower Passaic River (River Mile 10.9)
Project No. 60270961		
Photo No. 9	Date: 07062016

Direction Photo Taken: Southeast		
Description: Annual Cap Inspection Shoreline at station 16A-0608 during low tide event.		
Photo No. 10	Date: 07062016

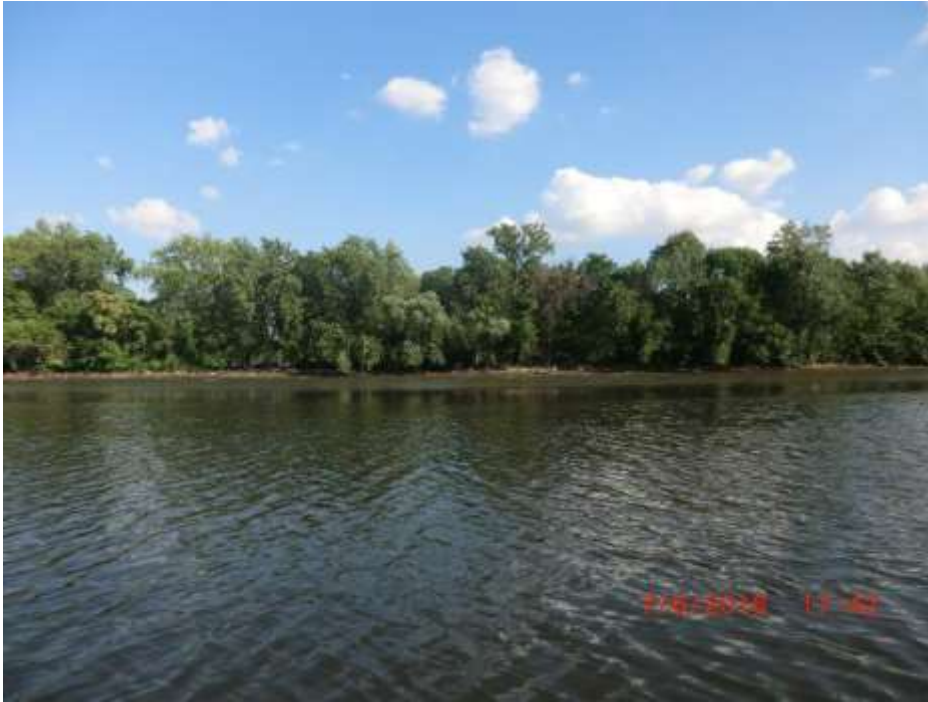
Direction Photo Taken: South		
Description: Annual Cap Inspection Shoreline during low tide event.
